# Failure Analysis of Centrifugal Pump Impeller in Textile Wastewater Using a Visual and Erosion-Corrosion Approach

The objective of this study is to analyze the failure mechanism of a centrifugal pump impeller used in textile wastewater service and propose engineering recommendations to improve pump reliability and operating life.

The object of this study was a failed centrifugal pump impeller used as a Return Activated Sludge (RAS) pump in a textile wastewater treatment plant located in Cimahi, Indonesia. The impeller operated for approximately 1.5 years before replacement due to significant performance reduction and severe material degradation.

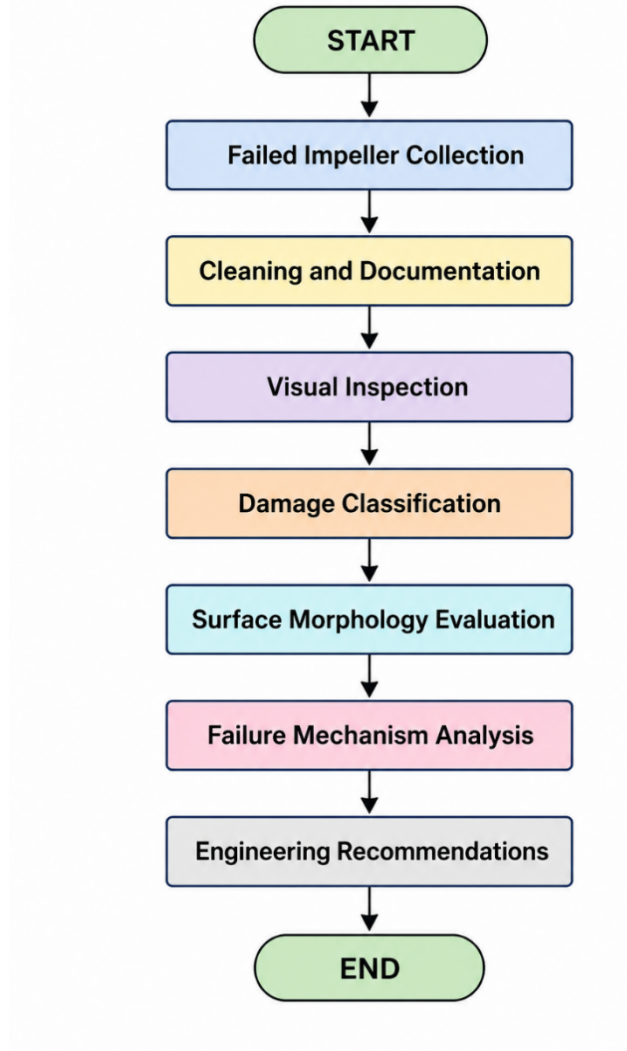
Figure 1. Research Methodology Flowchart

1. Failed impeller collection
2. Cleaning and documentation
3. Visual inspection
4. Surface morphology evaluation
5. Damage classification
6. Failure mechanism interpretation
7. Engineering recommendation development
