Assessment of Power System Equipment to Enhance the Power Quality at Dr. Saiful Anwar General Hospital Malang

Electrical conditions in the operations building and substation of the regional general hospital Dr. Saiful Anwarexperienced a power cut at optimum load, resulting in the power supply being solely obtained from the generator. The aim of the assessment carried out was to delve deeper into power quality, electrical performance, and other supporting equipment to maximize service to patients based on the assessment findings. The assessment stages utilized were the initial assessment stage and the detailed assessment stage. The analysis stages were conducted under steady-state load conditions. The assessment process involved field measurements, observations, and interviews with technical staff at the general hospital Dr. Saiful Anwar. Field measurements utilized Ammeters, Voltmeters, and Harmonic Analyzers to ascertain voltage imbalances, current imbalances, and harmonic content in SDP panels on each floor of the operations building, as well as to evaluate UPS components as backup power and stabilizers for electrical equipment. The results of observations and direct measurement

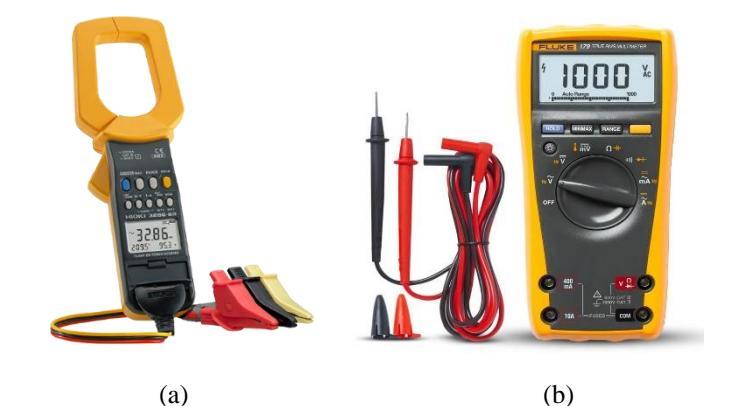
Figure 1. Measuring tools used : (a) Harmonics Analyzer and (b) AVO Meter

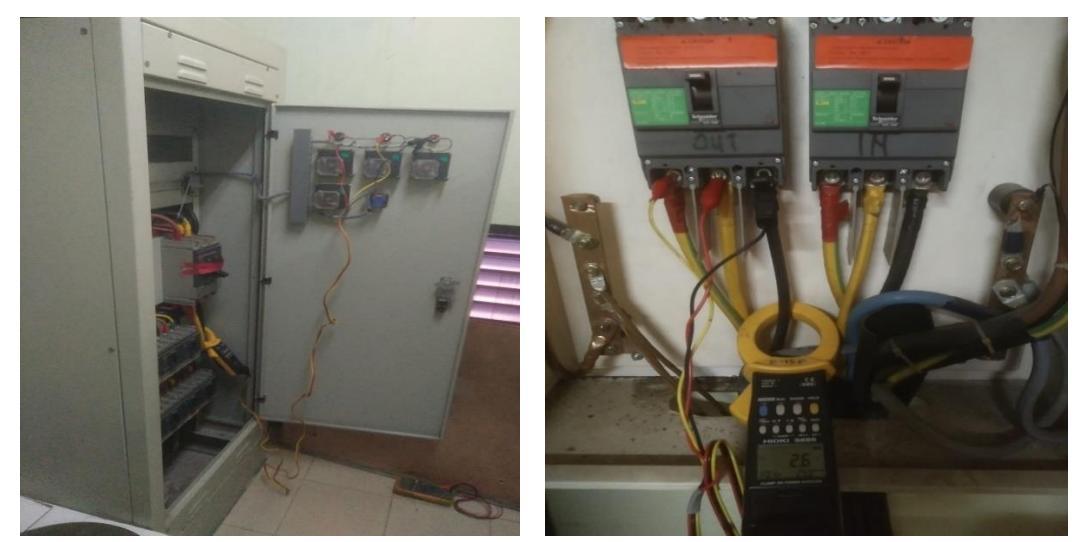
Figure 2. The process of measuring harmonic content with a harmonics analyzer

Table 1 explains the results of harmonic measurements with the help of a harmonics analyzer measuring instrument. The voltage harmonic content is still far below the standard, namely based on the IEEE 519-2014 standard for voltages below 1 kV. The permitted harmonic content limit is 8%, while the measured harmonics are an average of 1%. On the other hand,

when measuring the current harmonic content, the value is 3 times the permitted standard. The standards applied to current harmonics are according to IEEE standard 519 - 2014 with a value of iL/i_SC > 1000 with an operational voltage of 120 V - 69 kV, namely with a maximum limit of only 15% (Widagdo & Andriawan, 2023). However, the harmonic content of all equipment connected to the SDP panel of the 6th floor operations building is above 50%. So from these conditions, several indications that cause the magnitude of the harmonics are due to:

- a. The capacitor filter at the UPS output is not working optimally
- b. It's time to replace the battery (Accu) as a UPS supply
- c. Equipment grounding is not installed separately

Indications related to capacitors that do not work optimally cause the wave at the inverter output to not be filtered perfectly so that the pure sinusoidal wave is distorted and affects the measurement value of the harmonic content which is above the applicable standard. Then grounding equipment that is not installed separately causes harmonics originating from outside the grounding of the 6th floor surgical building to increase the harmonic in the SDP panel of the 6th floor surgical building. The recommended solutions to improve this condition so that the quality of electrical energy supply is maximized are given several suggestions (Widagdo & Budiono, 2023) :

- a. Replacement capacitor in UPS (Cap-Inverter) compartment
- b. UPS battery replacement
- c. Installation of special capacitors (filters) for harmonic networks

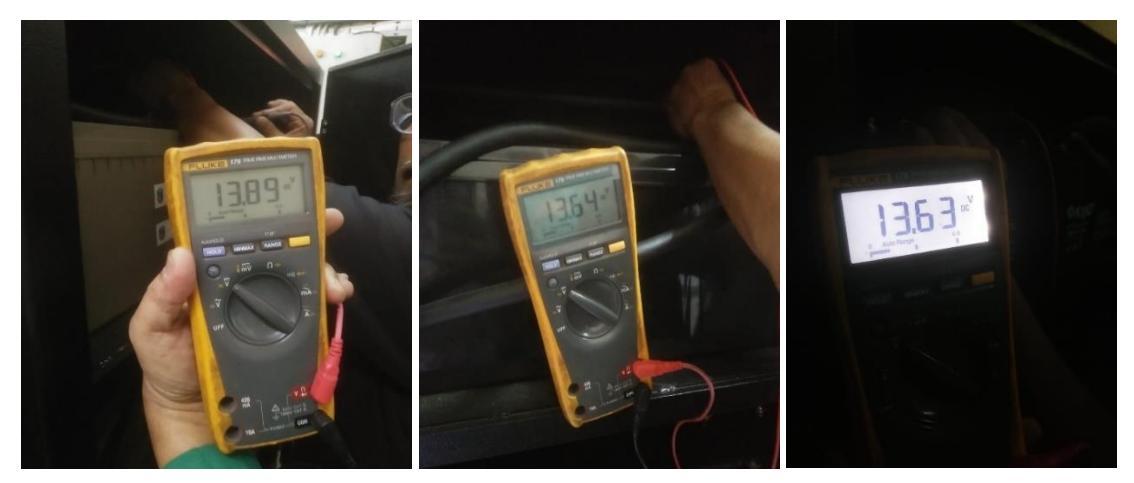
In another assessment related to UPS performance, measurements were carried out on the battery section, it was found that an overcharge had occurred. In Figure 3, when measuring the battery voltage, it can be seen that the battery for the UPS on the 6th floor of the operating building experienced an overcharge with a measured voltage value of 13.69 Volts, whereas when compared to the 4th and 5th floors the battery voltage was still in operating condition, namely 13. 64 Volts, this shows that there is a battery on the 6th floor as a UPS supply which is not operating optimally so it is recommended to replace the battery so that the UPS can back up optimally.

Figure 3. Measure the condition of the UPS on the part of the battery that is overcharged

- 1. It is necessary to test the battery capacitance either with an internal load or by bypass with the help of an external load.
- Because the operating temperature of the battery so that it can work for at least 6 years is 25°C, it is recommended to provide air conditioning and maintain the room temperature at 25°C.
- 3. Additional devices need to be provided including temperature sensors and voltage sensors to be able to monitor the minimum temperature of the battery when operating and voltage sensors are used to prevent overcharge.

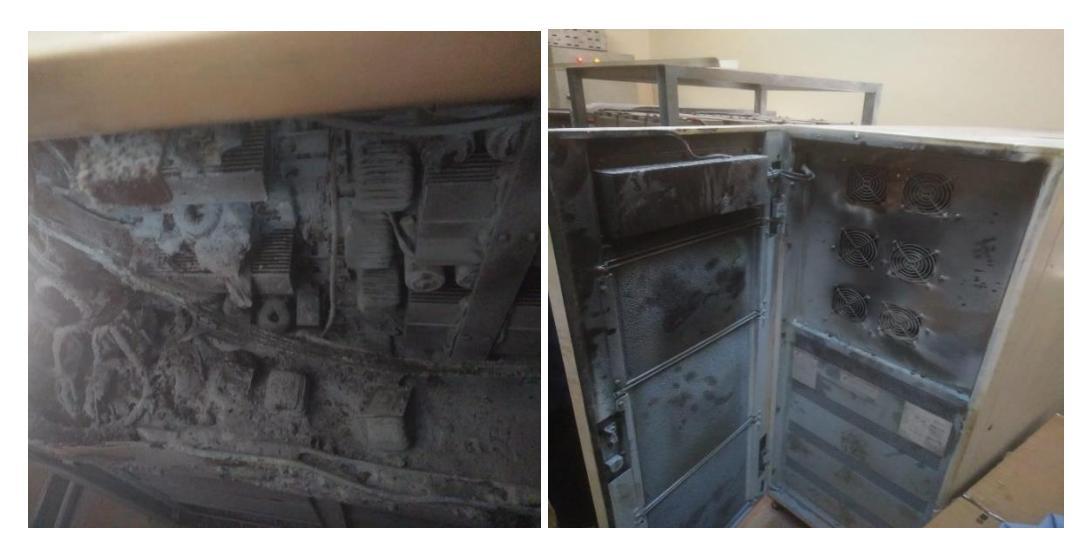
Figure 4. Condition of the UPS in the surgical building of regional general hospital Dr. Saiful Anwar Malang after the fire occurred

Assessing equipment on a UPS is important to ensure that the system functions optimally and can provide the necessary protection against power interruptions. From the results of the assessment carried out, the fire occurred due to overload or known as exceeding the capacity of the UPS equipment and also the inappropriateness of the UPS used. In Figure 4 there is a UPS type with a Transformer-less UPS type, while the UPS which should be used for types of equipment that have a large current rating value uses a UPS type with a Transformer-based UPS type.

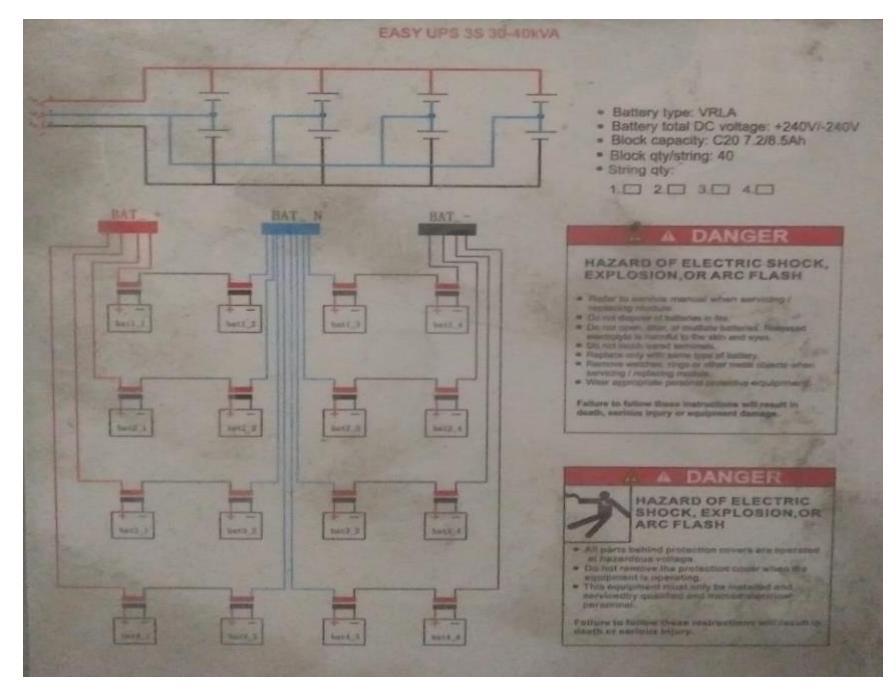
Figure 5. The Equivalent Circuit of a Transformerless UPS burns out.

In the context of power system security, the choice between transformer-based and transformerless UPS must consider the specific needs of the system and equipment being protected. Transformer-based UPS can provide better galvanic isolation protection, while transformer-less UPS can provide higher energy efficiency and lighter weight (Handayani et al., 2022).

The security of an electric power system depends not only on the type of UPS used but also on routine maintenance, proper selection of the load, and any additional security measures that may be required. Transformer-based UPS and transformer-less designs provide fundamental functionality and maintain their respective characteristics. It is clear that transformer-less UPSs dominate the market today. Transformer-less UPSs meet most of today's power supply design requirements, but for applications that require the highest reliability and safety such as the medical field, transformer-based UPS are the right choice (Yulianto, 2023).

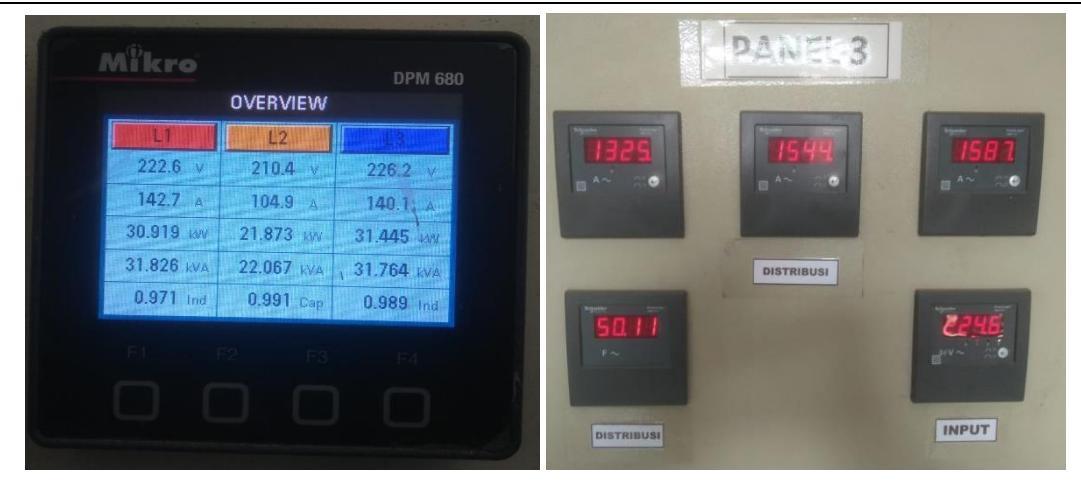
Figure 6. Monitoring voltage and current parameters that indicate unbalanced load

From the results of the field analysis, there was a problem of load distribution unbalanced at Substation 25. From the evaluation results, several points were obtained that needed further attention:

- a) Unbalanced voltage occurs, the consequences are dangerous for medical equipment that requires a supply voltage of 220 V
- b) The current of each phase is not balanced, as a result there will be a current flowing in the neutral wire
- c) The power factor according to PLN standards, namely $pf \ge 0.85 lag$
